## **Downers Grove Public Wells Nos. 6 & 8**

**ILD981958382**

### **Site Reconnaissance Visit Summary**

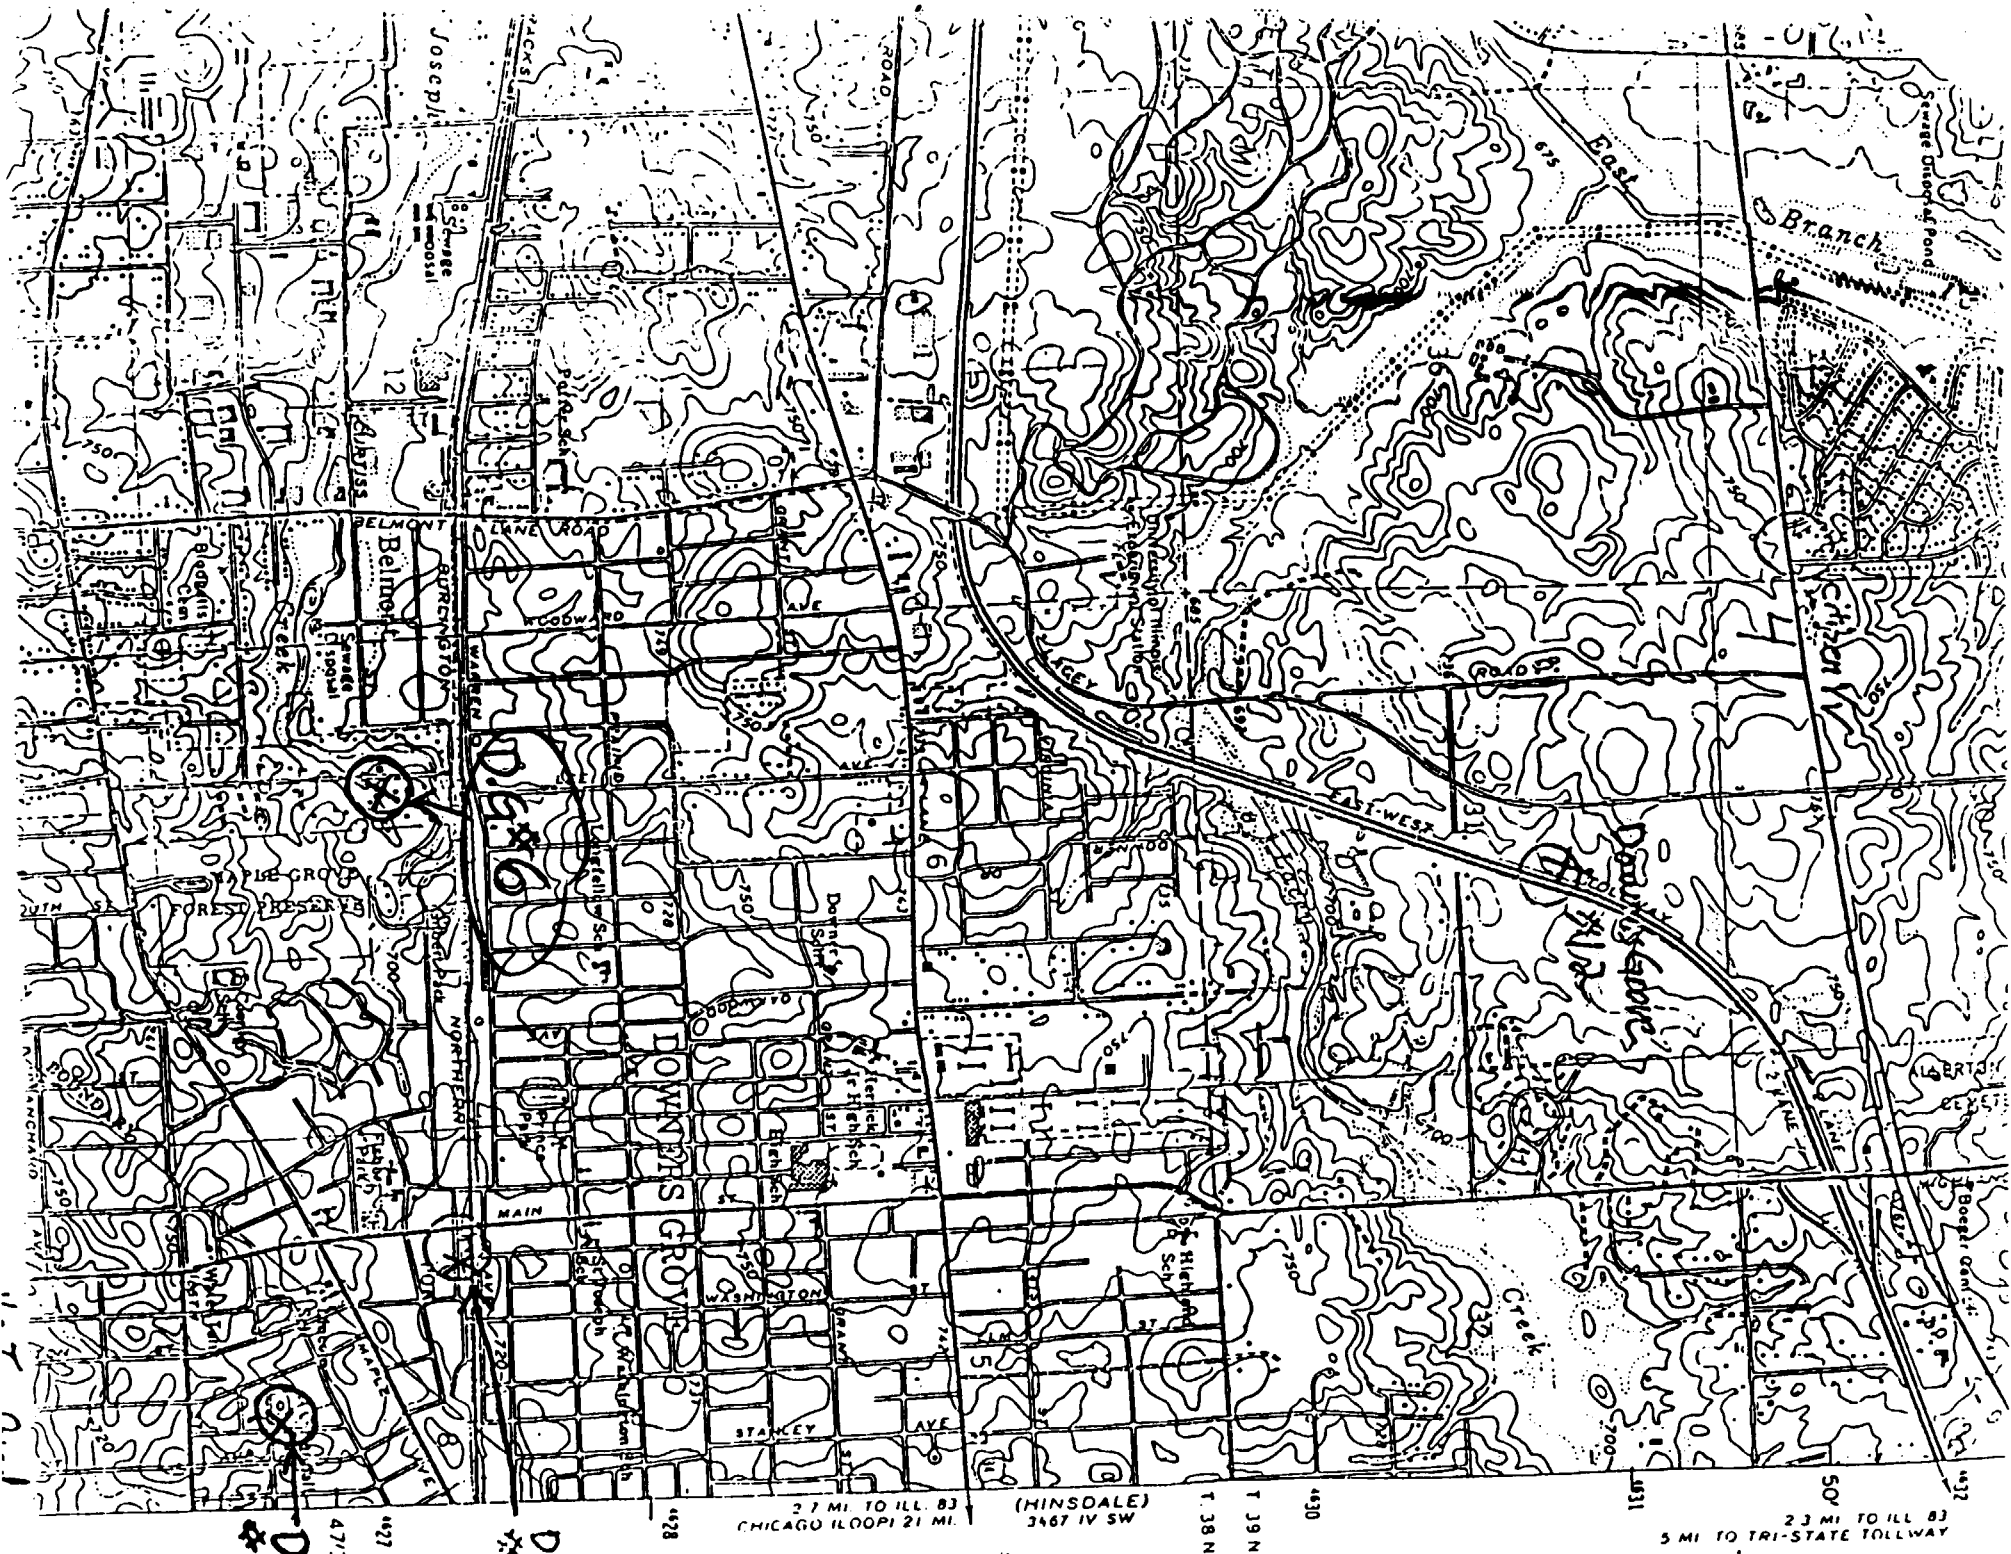
0430300 Downers Grove #6  
20107

Well No. 6 is housed in a brick single story structure similar to that housing well No. 8. Also known as the Lee Well because of its location on Lee Street, Well No. 6 is located approximately two hundred feet from St. Joseph Creek, in a residential area. The wellhouse is structurally sound and has a new roof. Well No. 6 has a blow-by line (approximately 8-inch diameter) which drains into St. Joseph Creek through a short storm sewer. When active, Well No. 6 pumps at a rate of 1,000 gallons per minute, drawing water from a shallow bedrock aquifer.
